Quality Assurance and Source Inspection

Contract #: 04-0120F4Cty: SF/ALA Rte: 80 PM: 13.2/13.9File #: 69.28**WELDING INSPECTION REPORT****Resident Engineer:**Pursell, Gary**Address:** 333 Burma Road**City:** Oakland, CA 94607**Report No:** WIR-006884**Date Inspected:** 24-May-2009**Project Name:** SAS Superstructure**OSM Arrival Time:** 700**Prime Contractor:** American Bridge/Fluor Enterprises, a JV**OSM Departure Time:** 1600**Contractor:** Zhenhua Port Machinery Company, Ltd (ZPMC), Changxing Island **Location:** Shanghai, China**CWI Name:** Chen Xi**CWI Present:** Yes No**Inspected CWI report:** Yes No N/A**Rod Oven in Use:** Yes No N/A**Electrode to specification:** Yes No N/A**Weld Procedures Followed:** Yes No N/A**Qualified Welders:** Yes No N/A**Verified Joint Fit-up:** Yes No N/A**Approved Drawings:** Yes No N/A**Approved WPS:** Yes No N/A**Delayed / Cancelled:** Yes No N/A**Bridge No:** 34-0006**Component:** OBG crossbeams**Summary of Items Observed:**

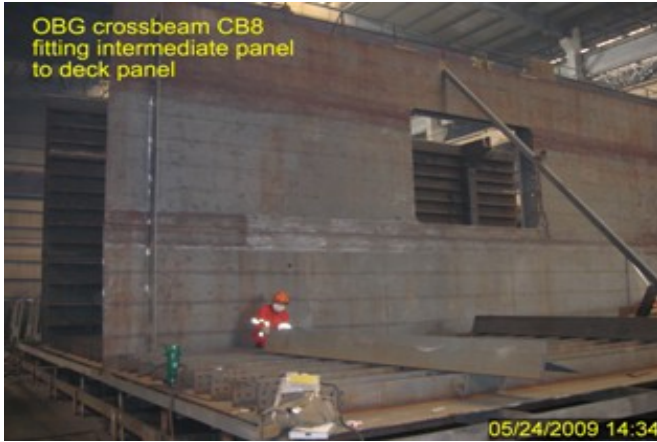
This QA performed Visual Testing (VT) of material and welds after the contractor sandblasted the outside surfaces of this crossbeam. This QA observed one area of porosity on the west side panel where a temporary weld was removed. This area was marked for repair and recorded on the weld repair tracking log for this crossbeam.
